INDOOR AIR QUALITY ASSESSMENT

**Department of Children and Families
80 Everett Ave.
Chelsea, Massachusetts**

Prepared by:
Massachusetts Department of Public Health
Bureau of Environmental Health
Indoor Air Quality Program
August 2019

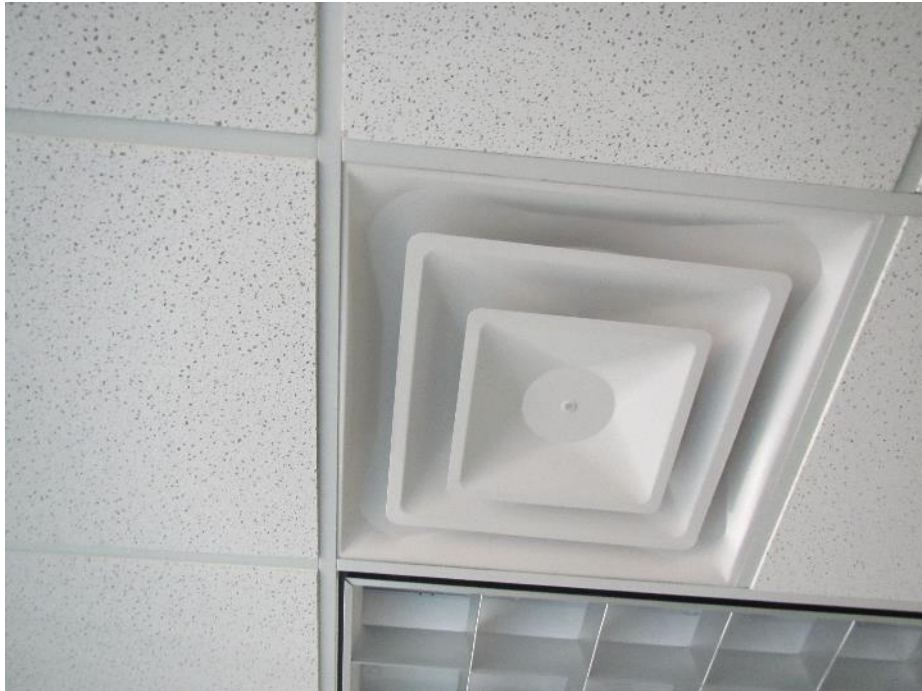
Picture 1

HVAC system consists of air handling units (AHUs) located on the roof, which draw in outside air and heat/cool it. Fresh air is delivered to spaces via ceiling-mounted supply vents (Picture 1). Return air is drawn into an above-ceiling plenum via ceiling grates (Picture 2) and ducted back to AHUs. Supplemental cooling in some areas is provided by wall-mounted ductless air-conditioning (AC) units.

Supply vent

3. Regularly clean supply and return vents.
4. Periodically check the function of restroom exhaust vents and repair as needed.
5. Balance the HVAC system every 5 years in accordance with Sheet Metal and Air Conditioning Contractors' National Association (SMACNA) recommendations (SMACNA, 1994).

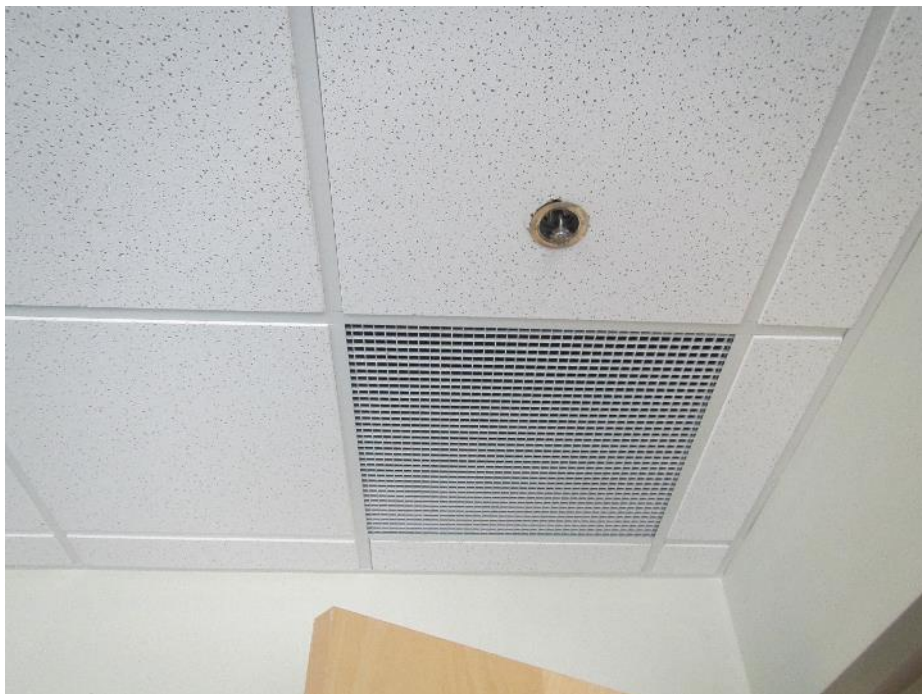
Picture 2

Return grate

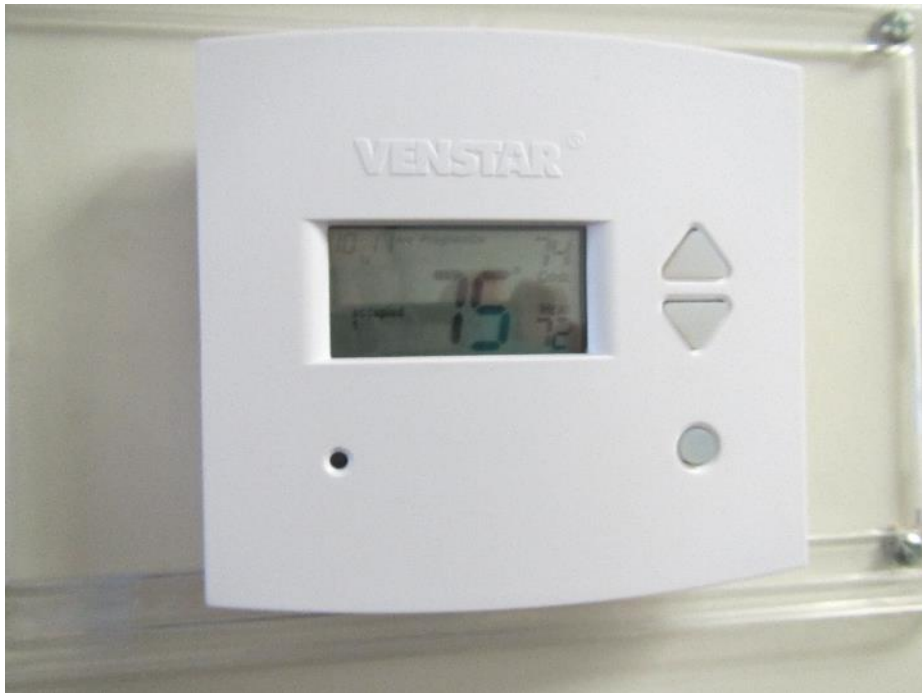
Picture 3

The HVAC system is controlled by digital thermostats. Thermostats examined were in “occupied” mode (Picture 3). It could not be determined if the “occupied” mode provided for continual air circulation during occupied hours or if this was just used to determine the temperature settings for the building. When the system fans are continually on, as recommended during occupied hours, the system provides a continuous source of air circulation and filtration. An “automatic” setting would instead activate the HVAC system based on pre-set temperature and only supply fresh/filtered air when heating or cooling was called for in the space.

Thermostat set to "occupied"

1. Operate supply and exhaust ventilation continuously in all areas during occupied periods. Ensure all HVAC equipment is cleaned/maintained in accordance with manufacturer's instructions.

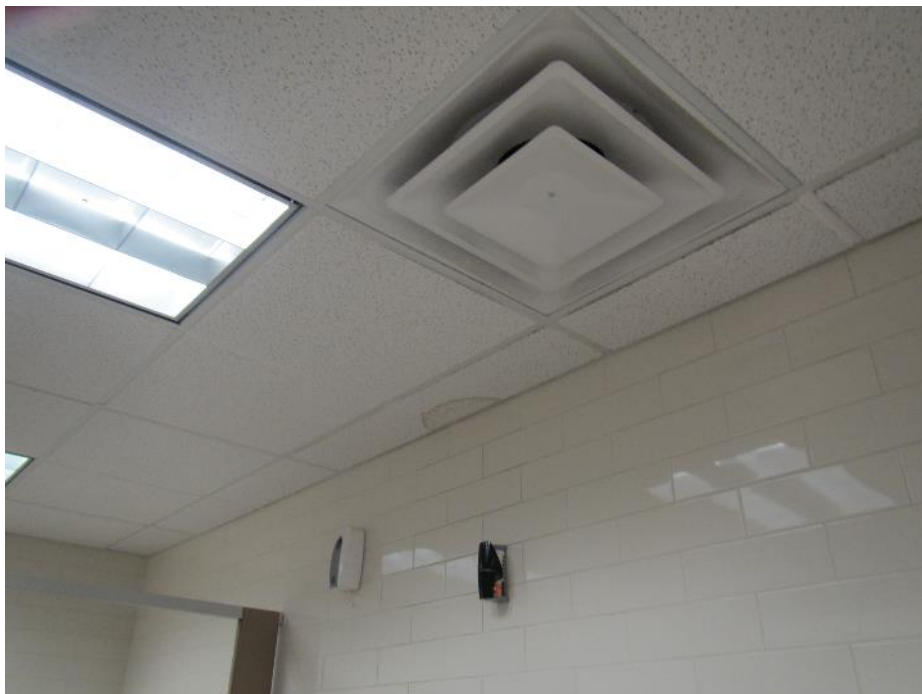
Picture 4

Light water stains were noted in the 2nd floor women's restroom (Picture 4; Table 1). This likely is the result of a leak/condensation in the plumbing or sprinkler system. The area above this ceiling tile should be examined for the source of the leak and for any additional water-damaged materials. Once the leak is repaired, the affected ceiling tiles should be replaced. Water-damaged plaster and other materials were noted along the exterior wall in a few places. The most prominent plaster damage was found in the entrance vestibule (Pictures 5 and 6). This appears to be due to gaps between the main building and the vestibule, which may to have been a later addition to the building (Picture 7). Materials with water damage in this area appear to be plaster, which is resistant to mold growth; however the source of the damage (e.g., missing/damaged flashing) and any damaged areas should be repaired. Another area with damaged plaster was noted near windows on that same side of the building.

Water stain on ceiling tile in women's restroom

6. Replace water-damaged ceiling tiles and repair damaged plaster. Examine spaces above/behind areas of water damage to determine if any hidden damage or odors have occurred.

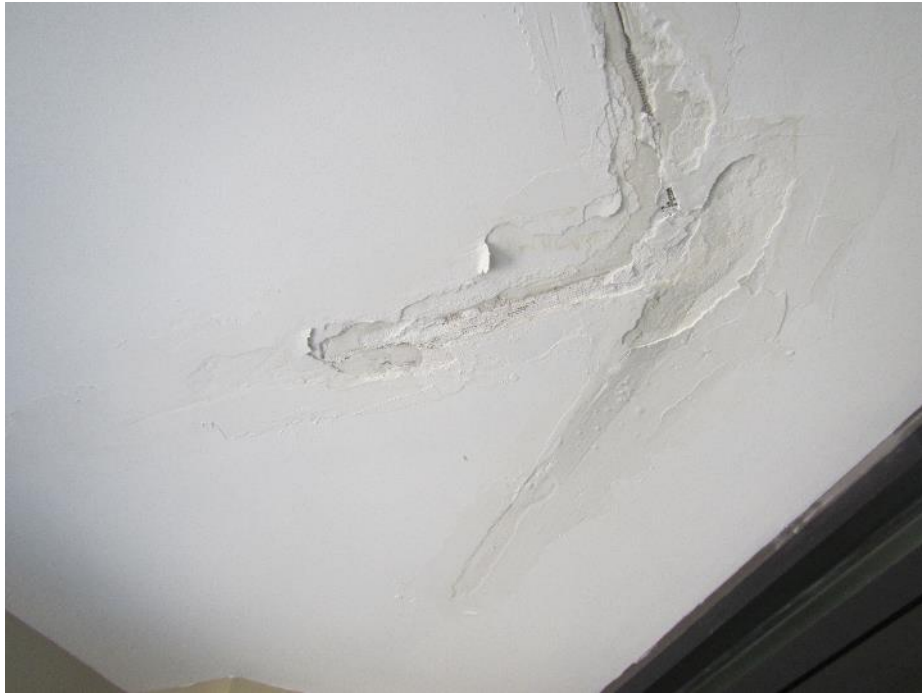
Picture 5

Damaged plaster in vestibule

7. Have the flashing and roof membrane between the brick vestibule and the rest of the building checked for gaps and repair as needed.
8. Keep plants and flowers in good condition, avoid overwatering, and remove from the airstream of heating and ventilation equipment.

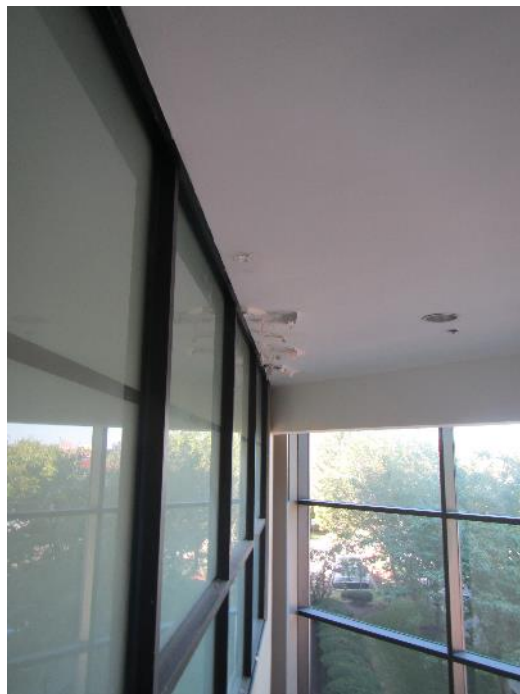
Picture 6

Damaged plaster in vestibule

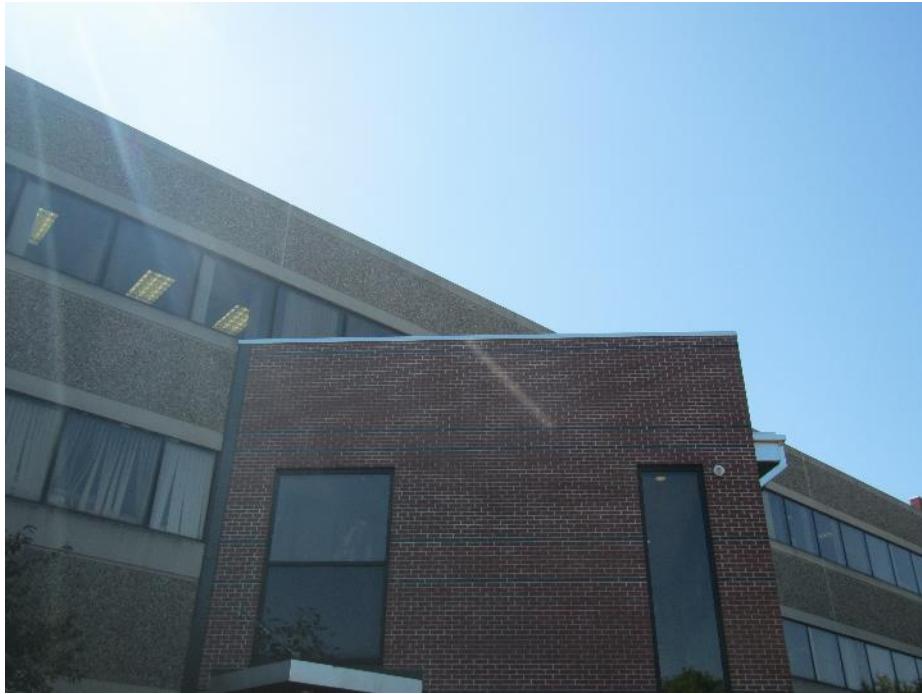
Picture 7

Vestibule shown in Pictures 5 and 6, likely an addition to the building

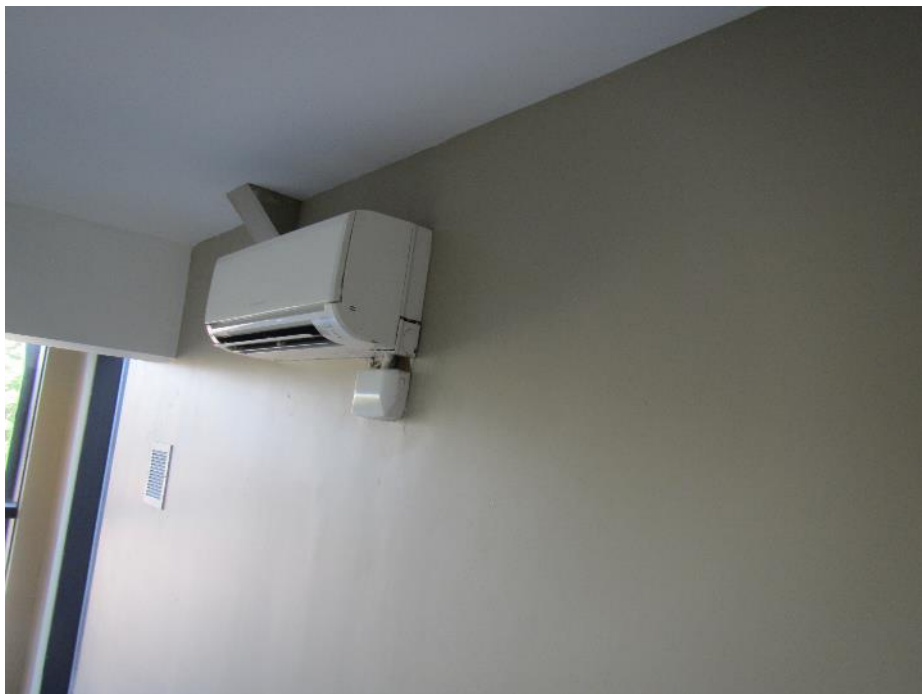
Picture 8

There were also reported leaks from ductless air conditioning units (Picture 8). Condensation drains from these units can develop clogs which can lead to leaks. The units and drains/piping/pumps should be examined periodically and cleaned or repaired if clogs develop.

Ductless air conditioning unit with signs of leaks

9. Keep aquariums in good condition.
10. Consider a regular inspection program for ductless air conditioning condensation systems to prevent clogs and leaks. Dry, repair or replace any plaster, wallboard or carpeting moistened by leaks from ductless air conditioners as needed.

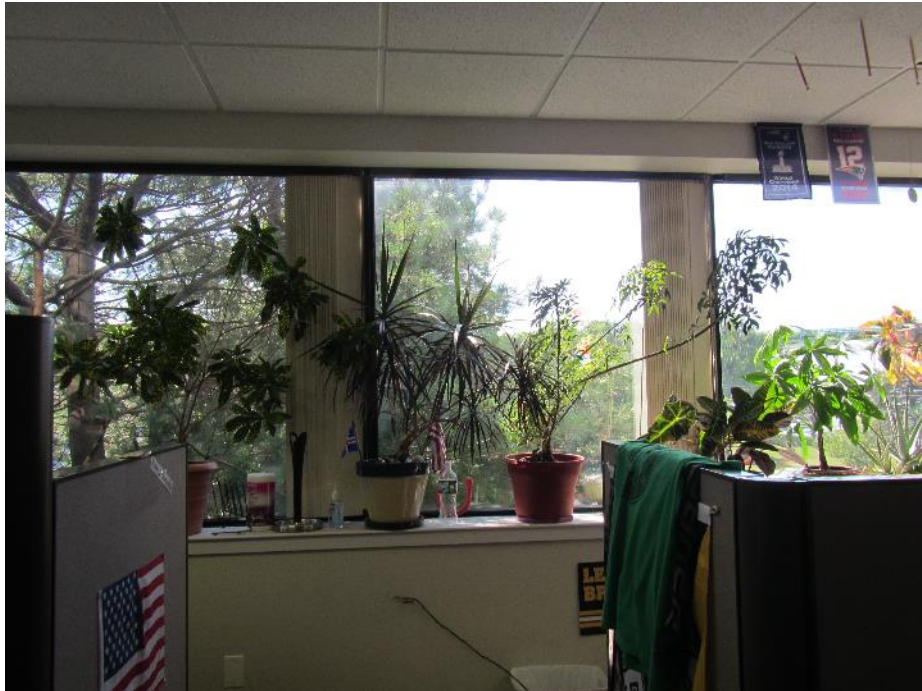
Picture 9

Plants were noted in many areas (Picture 9; Table 1). Plants should be properly maintained and equipped with drip pans and should be located away from airflow to prevent the aerosolization of dirt, pollen, and mold. Aquariums were also found in several offices, including one that had murky water (Picture 10; Table 1). Aquariums should be kept clean so they don't become a source of odors.

Plants in the office

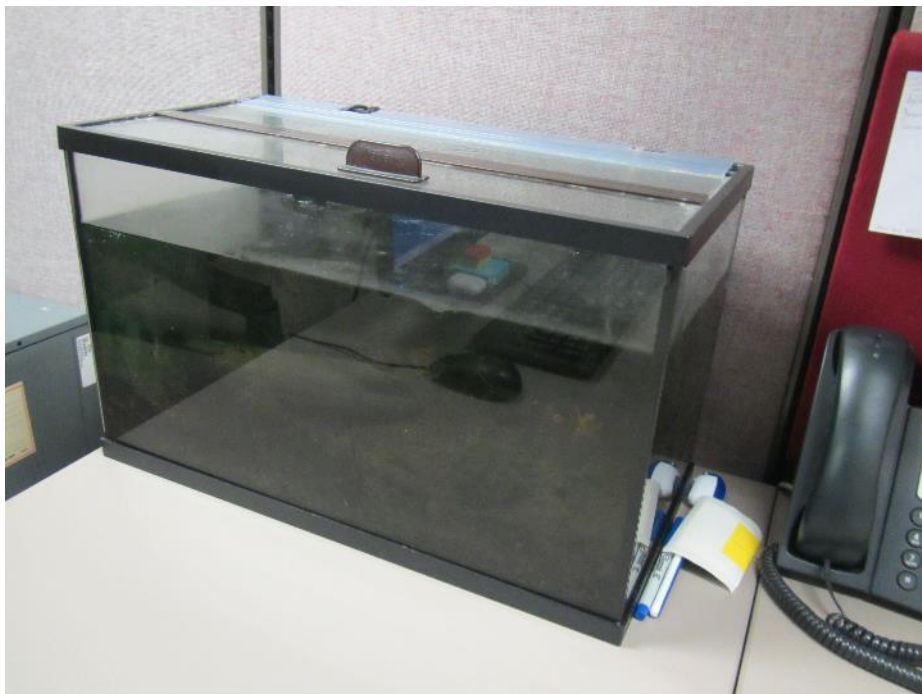
Picture 10

Murky water in an aquarium

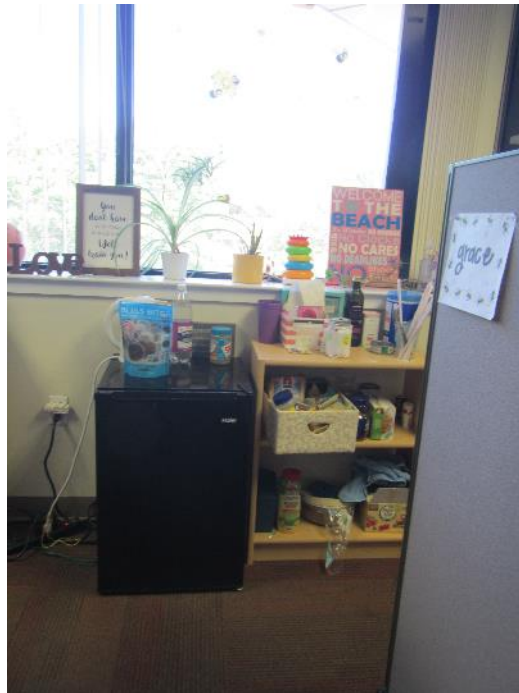
Picture 11

Refrigerators and water dispensers were located on carpet (Picture 11). Refrigerators and water dispensing equipment should be located in a non-carpeted area or on a waterproof mat to prevent damage to carpet and subsequent odors. Many individual offices and groups of cubicles had small refrigerators. If these are not kept clean and in good repair, they may become a source of odors and microbial growth. Consider limiting the number of refrigerators on the floor and consider developing a system to ensure that refrigerators are cleaned on a regular basis, including when office occupants are on vacation.

Small refrigerator on carpet

11. Consider placing refrigerators and water dispensers in areas without carpeting, or use a waterproof mat to protect carpeting.
12. Trim trees and plants away from the building to at least five feet.

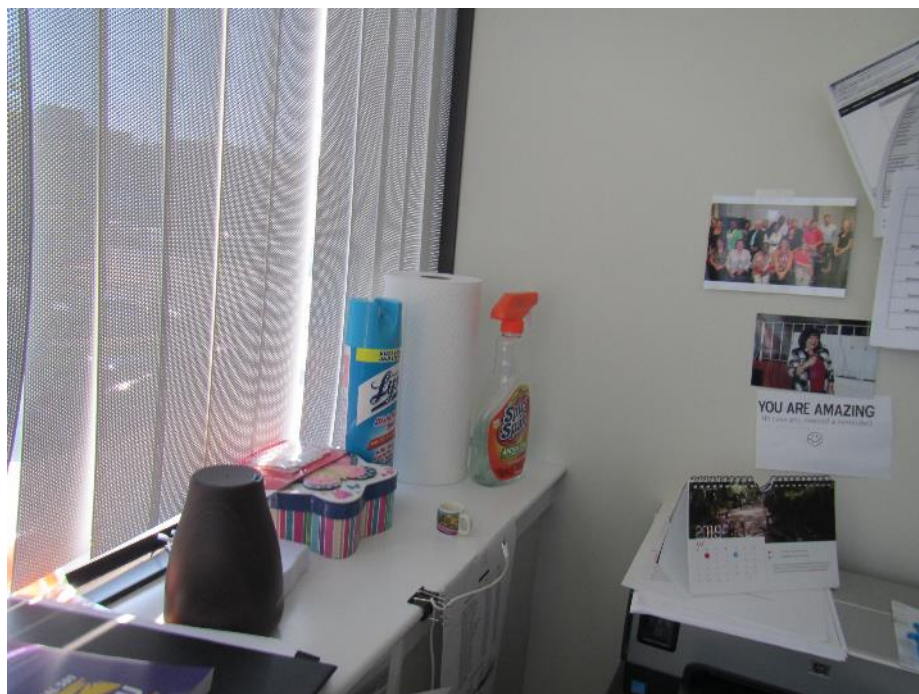
Picture 12

Exposure to low levels of total volatile organic compounds (TVOCs) may produce eye, nose, throat, and/or respiratory irritation in some sensitive individuals. BEH/IAQ examined spaces for products containing VOCs. BEH/IAQ staff noted hand sanitizers, cleaners, and dry erase materials in the office space (Picture 12; Table 1). All of these products have the potential to be irritants to the eyes, nose, throat, and respiratory system of sensitive individuals.

Cleaning products

14. Reduce the use of cleaning products, sanitizers, and other items that contain VOCs.
15. Keep food preparation equipment clean, and clean out refrigerators, including the gaskets, regularly. Because of the large number of small refrigerators, consider developing a tracking program to ensure all refrigerators are cleaned out periodically.
